**Issue No: 02/23**

**The aim of this Safety Matters is to highlight the potential dangers in flight crew using night vision goggles**

# Night Vision Goggles

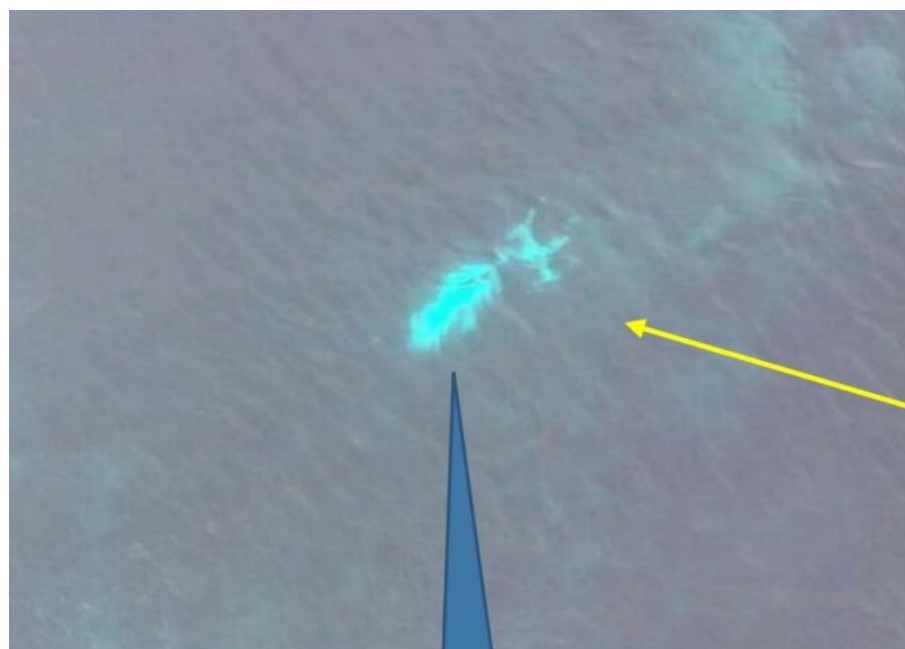
Wreckage

The pilot misinterpreted the image seen through the NVGs as being cloud covering the landing area when it was very likely to have been fog near the sea surface and downwind of the shore.

The planned descent and approach in the clear area was made using visual reference outside and to the GPS map display. However, the helicopter's descent rate became high as the pilot, relying primarily on visual depth perception, believed the helicopter was further from the surface of the sea than it was.

When the crew did see an image through the NVGs it was the 20-metre high cliffs several hundred metres ahead and above them. During the manoeuvre to avoid the cliffs, the helicopter impacted the sea.

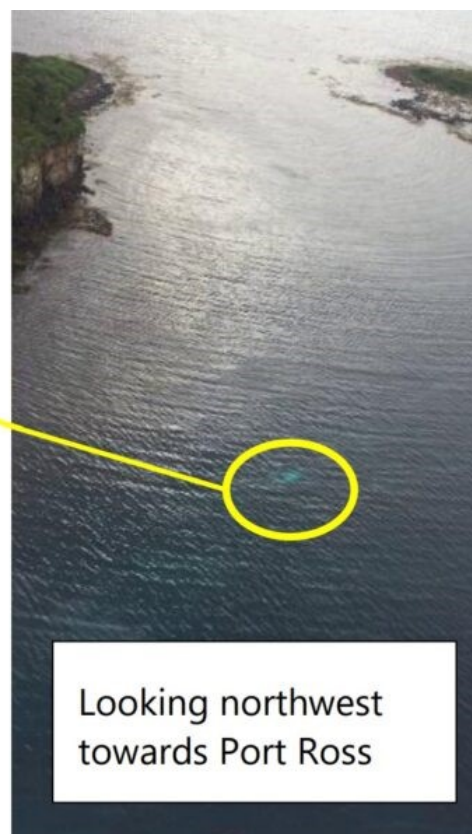
Looking northwest towards Port Ross

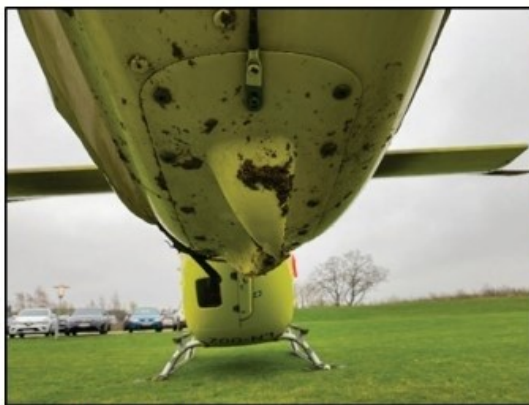
Picture no. 1 – Damaged tail bumper

Suddenly and without warning, the commander saw only bright light within his NVG. The commander was startled, but noticed a RH indication of 50 ft on his Primary Flight Display and tried to obtain outside visual references by looking below the NVG, but saw only darkness. As the commander initiated a go-around the helicopter contacted the ground in a field 210 m short of the helipad.

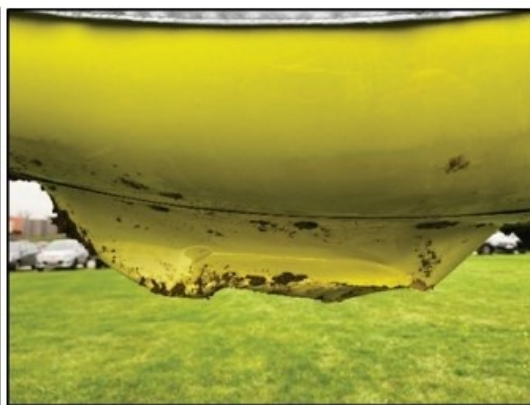
Picture no. 2 – Damaged tail bumper

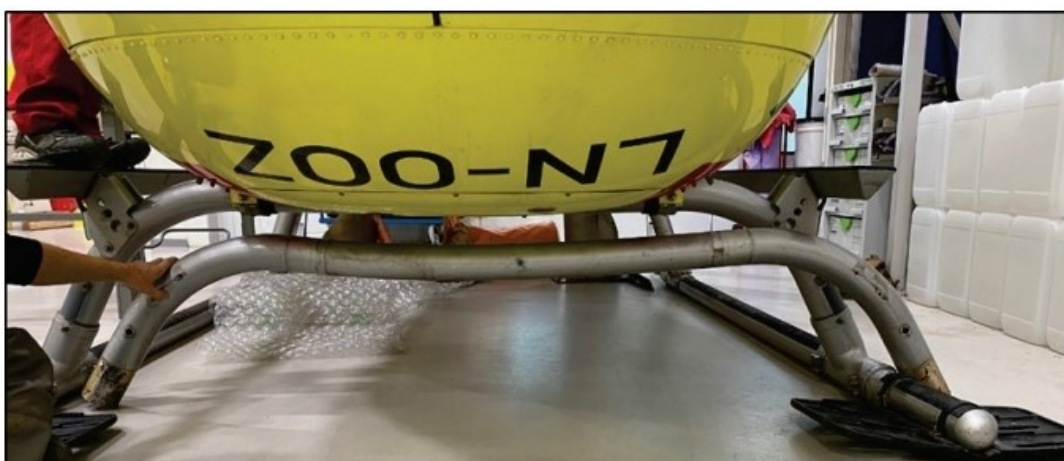
Picture no. 3 – Removed damaged aft crossbeam compared to new installed.  
The square black rubber plates mounted on the lower aft part of each skid are known as bearpaws.
